Home Inspection Report

Inspected on Tue, Aug 7 2018 at 3:07 PM

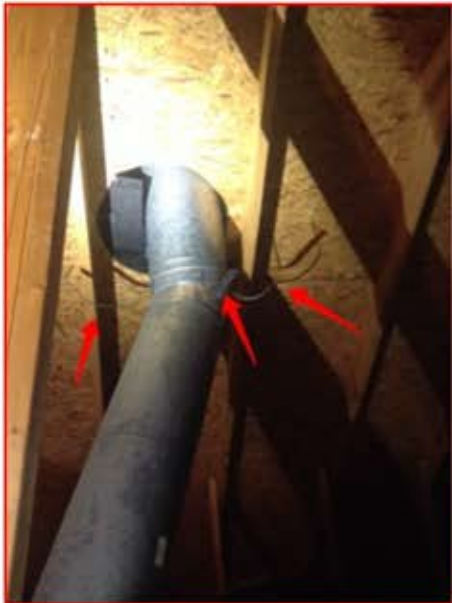
Figure 1-1

1) Comment 1: Straps to secure the chimney to the roof rafters are not fastened. This could allow the chimney to be damaged in high wind. Recommend having a qualified carpenter repair.

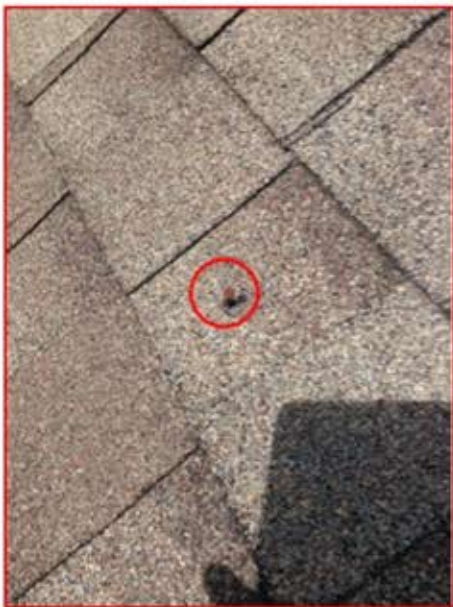
Figure 2-1

2) Comment 2: Nail pop from the underlying shingle. This will cause a future leak. Recommend having a licensed roofer repair. This is above the front door and to the right.

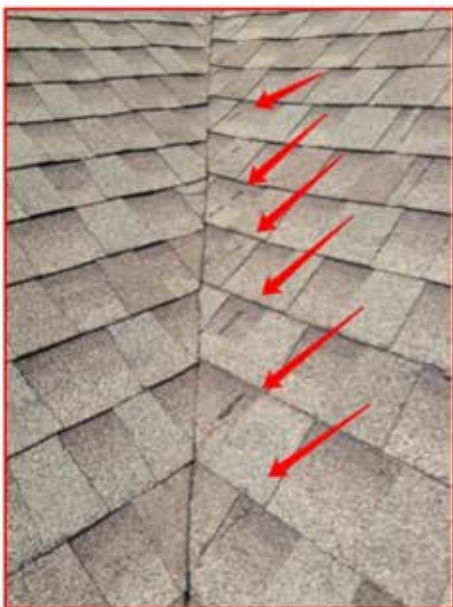
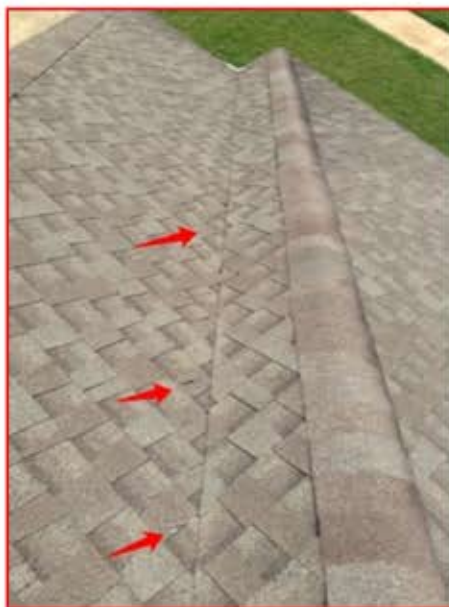
3) Comment 3: Shingles in several of the valleys show signs of significant wear. Recommend having a licensed roofer further evaluate.

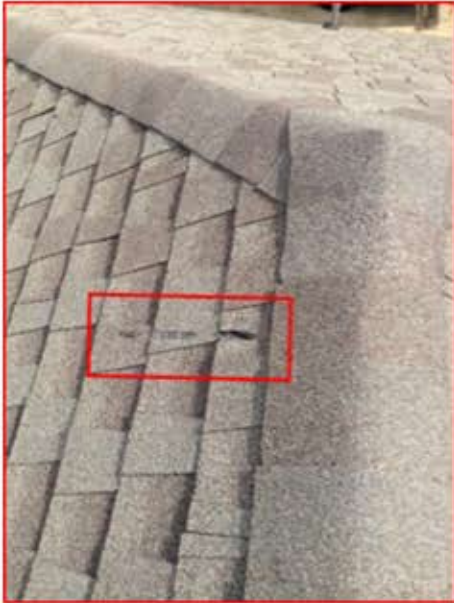
Figure 4-1

4) Comment 4: Shingle with a significant crack that could cause a leak. Recommend having a licensed roofer further evaluate. This is on the back side towards the driveway.

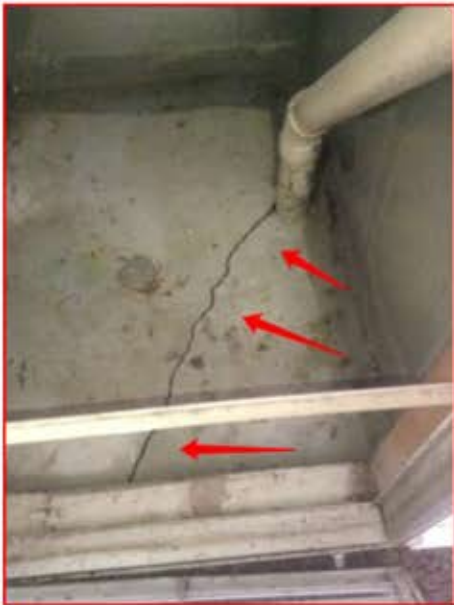
Figure 5-1

5) Comment 5: 1/4" crack in the slab under the A/C in the hallway. Recommend having a foundation specialist further evaluate.

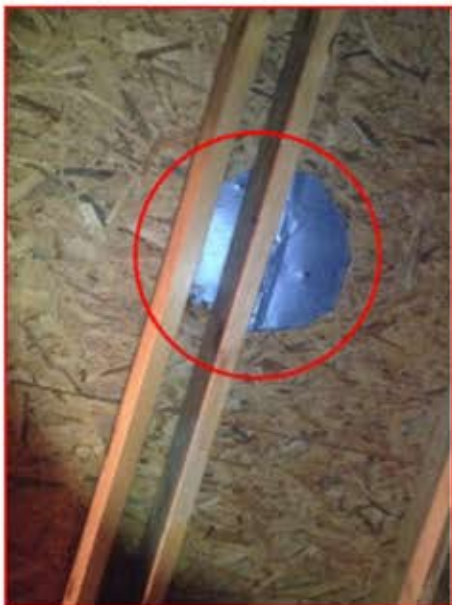
Figure 6-1

6) Comment 6: Hole in roof decking that was covered with metal and has shingles over it. Recommend asking current owner if they have any information on what was repaired.

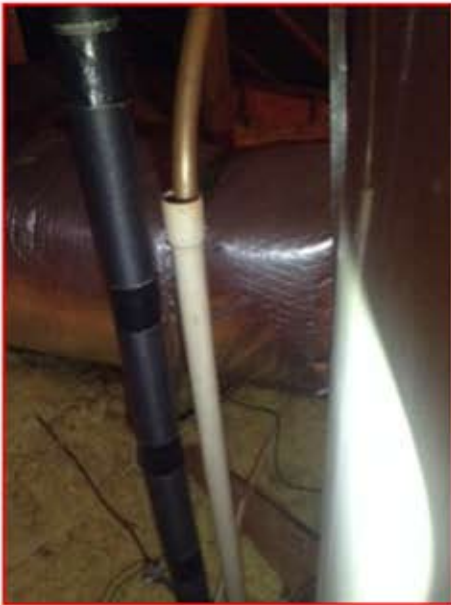
Figure 13-1

8) Comment 13: Temperature and blow off leg is piped to PVC. This should be piped to CPVC. Recommend having a qualified plumber further evaluate. PVC is not rated to withstand hot water.

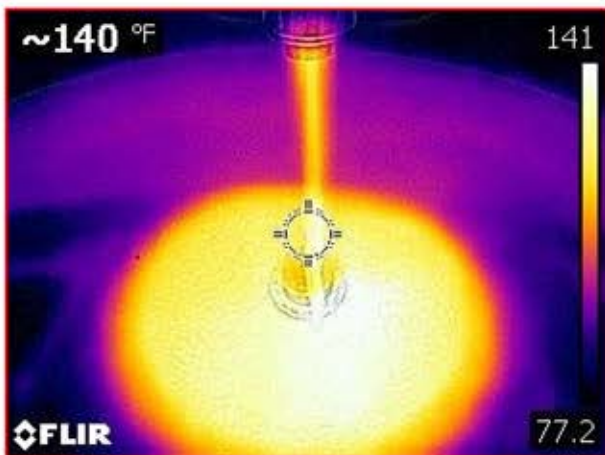
Figure 14-1

9) Comment 14: Hot water was measured at 140f. Recommend having a qualified plumber turn down the temperature to prevent someone burning themselves.

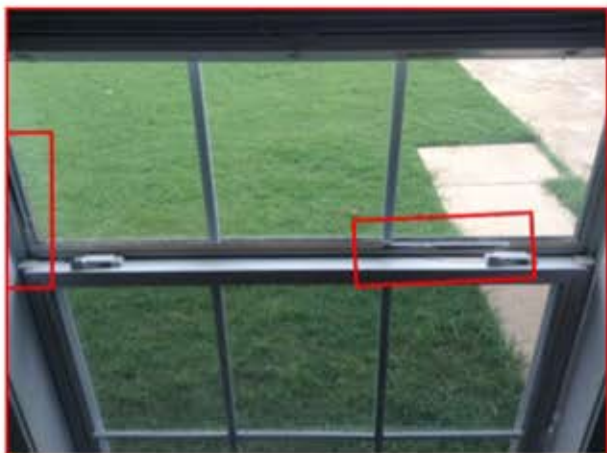
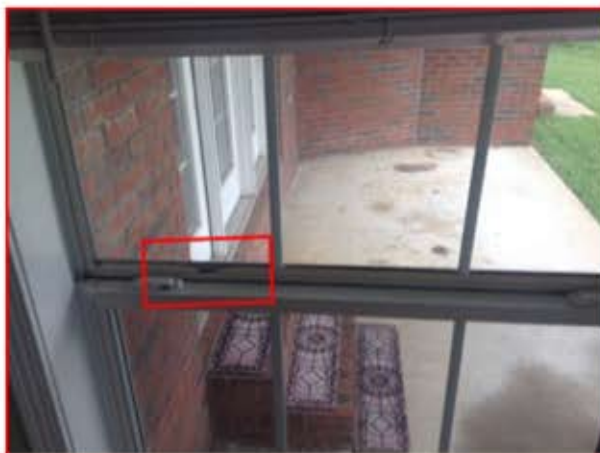
11) Comment 17: Several of the windows have some wear on the seal around the window panes. Recommend having a qualified window contractor such as weather seal to further evaluate.

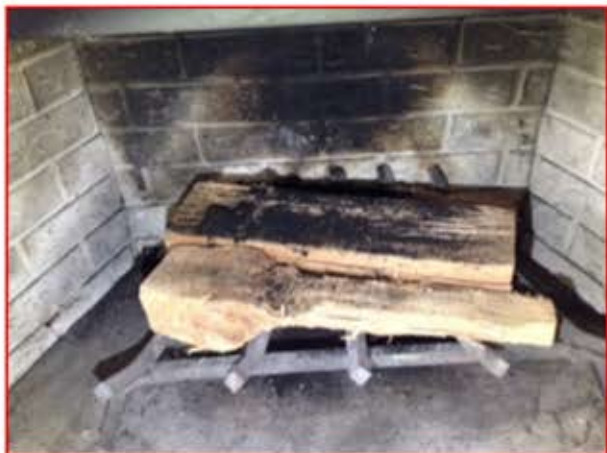
Figure 18-1

12) Comment 18: Chimney has a lot of creosote. This could cause a chimney fire. Recommend having a chimney sweep further evaluate and clean if necessary.

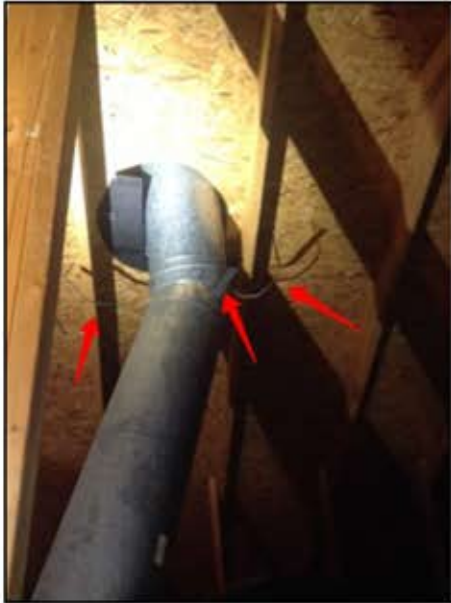
Figure 1-1

Straps to secure the chimney to the roof rafters are not fastened. This could allow the chimney to be damaged in high wind. Recommend having a qualified carpenter repair.

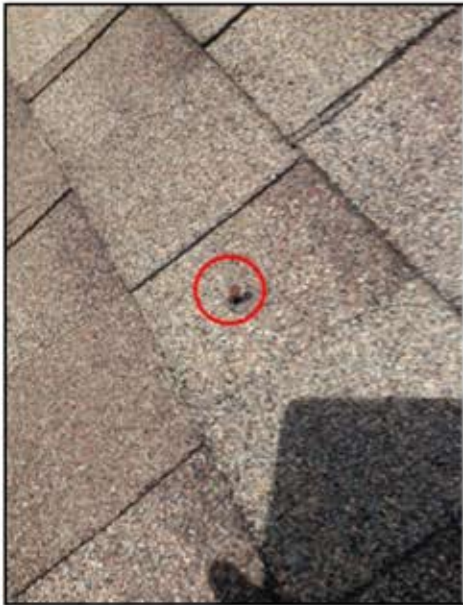
Figure 2-1

Nail pop from the underlying shingle. This will cause a future leak. Recommend having a licensed roofer repair. This is above the front door and to the right.

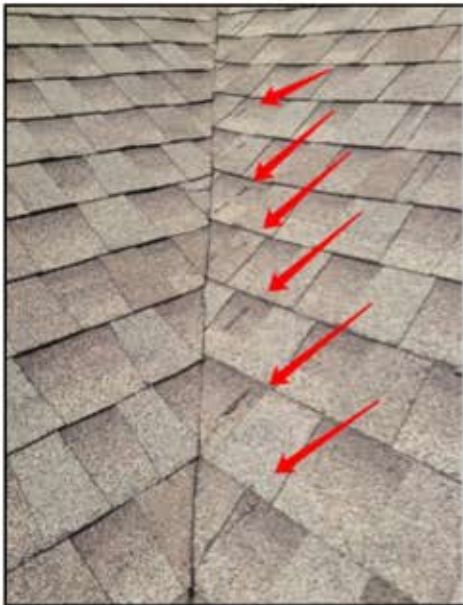
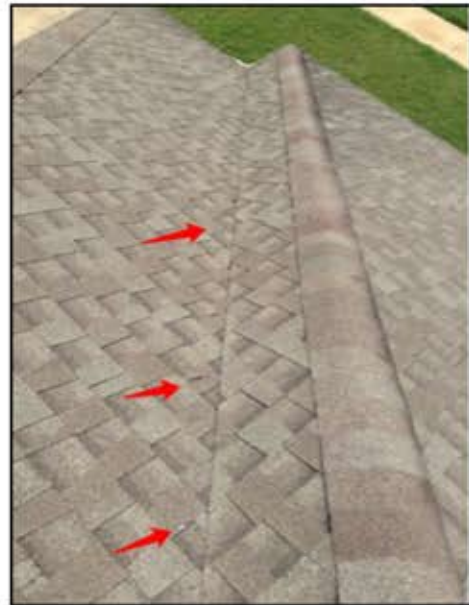
Shingles in several of the valleys show signs of significant wear. Recommend having a licensed roofer further evaluate.

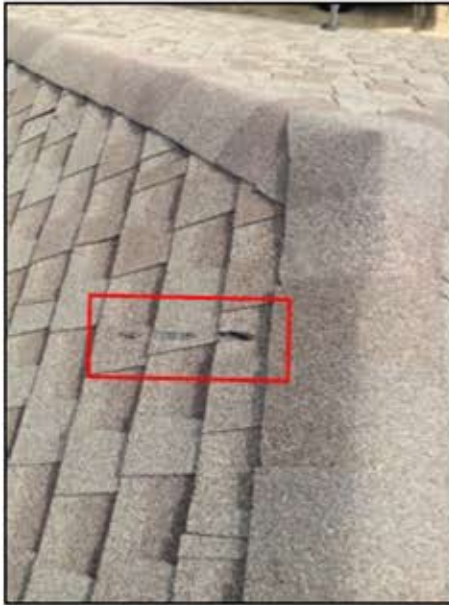
Figure 4-1

Shingle with a significant crack that could cause a leak. Recommend having a licensed roofer further evaluate. This is on the back side towards the driveway.

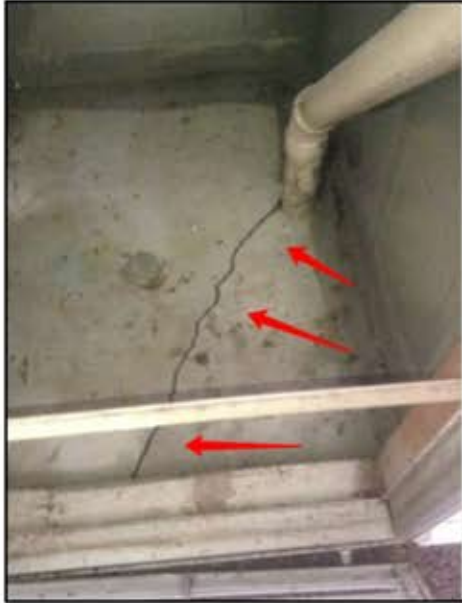
Figure 5-1

1/4" crack in the slab under the A/C in the hallway. Recommend having a foundation specialist further evaluate.

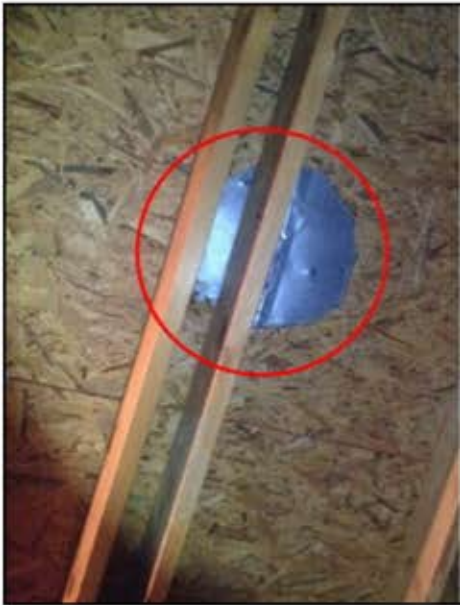
Figure 6-1

Hole in roof decking that was covered with metal and has shingles over it. Recommend asking current owner if they have any information on what was repaired.

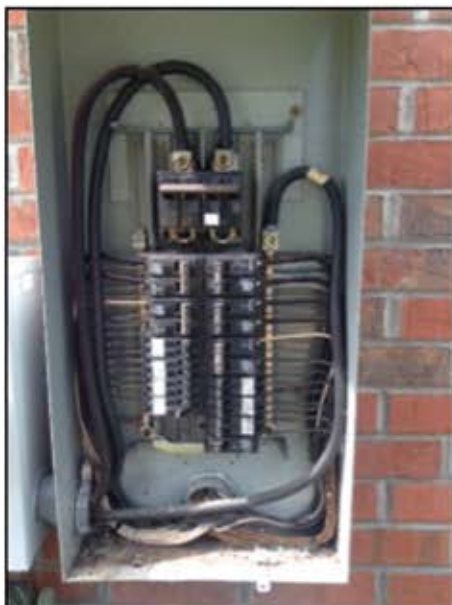
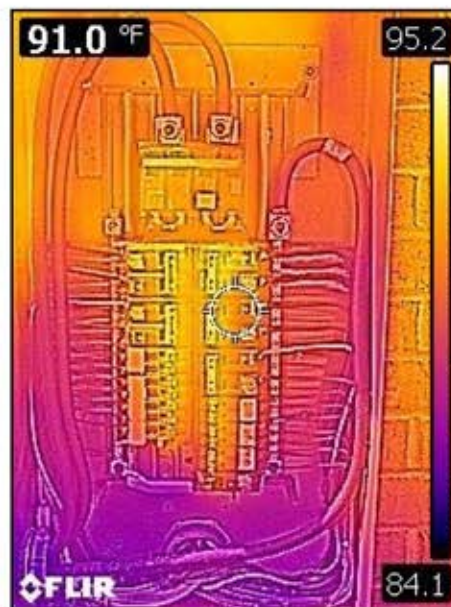
All breakers appear normal through the FLIR infrared camera.

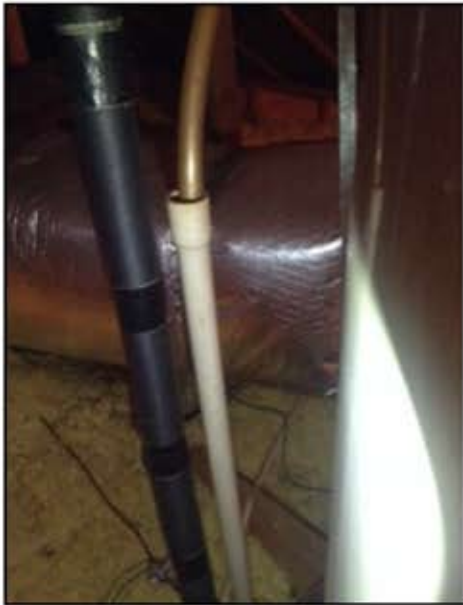
Figure 13-1

Temperature and blow off leg is piped to PVC. This should be piped to CPVC. Recommend having a qualified plumber further evaluate. PVC is not rated to withstand hot water.

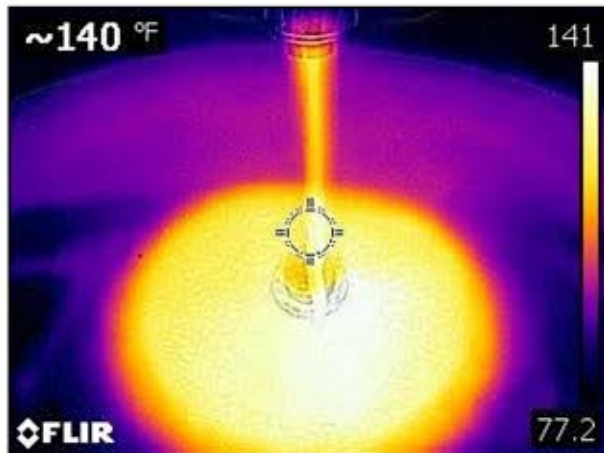
Figure 14-1

Hot water was measured at 140f. Recommend having a qualified plumber turn down the temperature to prevent someone burning themselves.

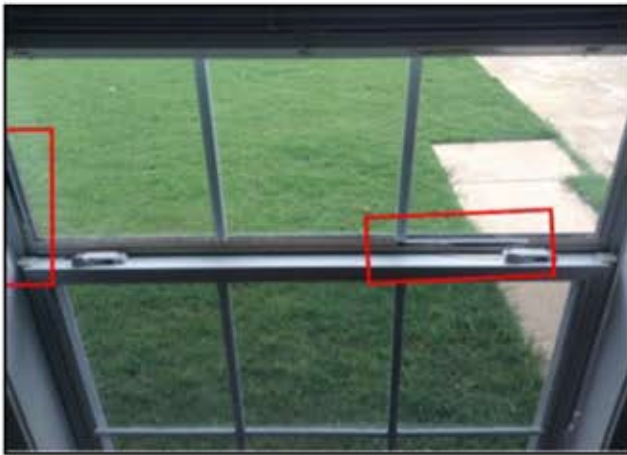
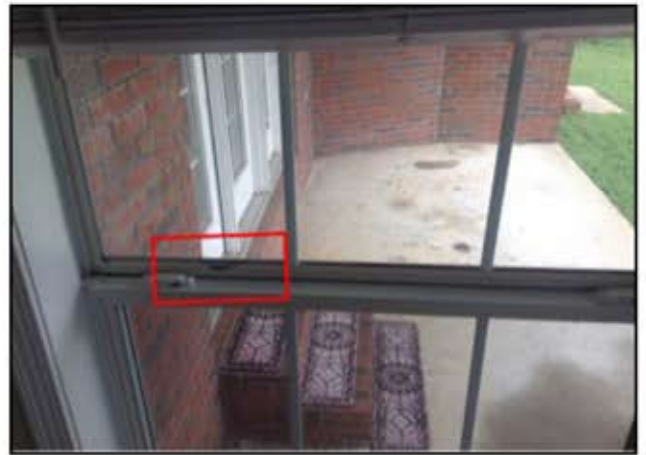
Several of the windows have some wear on the seal around the window panes. Recommend having a qualified window contractor such as weather seal to further evaluate.

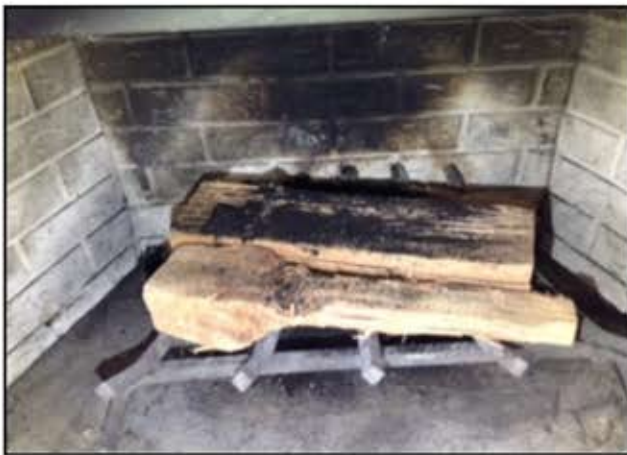
Figure 18-1

Chimney has a lot of creosote. This could cause a chimney fire. Recommend having a chimney sweep further evaluate and clean if necessary.
